GEARBOX SERVICES INTERNATIONAL

Discipline Machine Diagnostics

The services of our Machine Diagnostics:

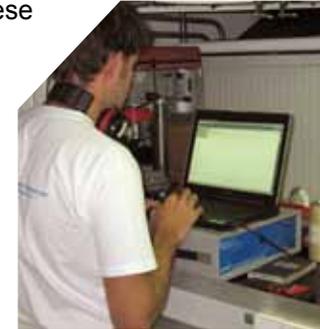
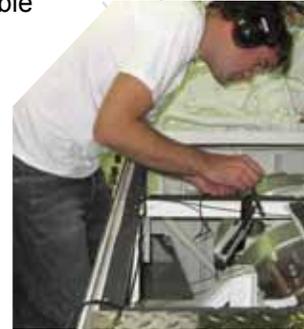
Our machinery experts at GBS international are capable of providing inspections on an individual basis or as part of a contractual agreement in order to assess the health or condition of your machinery. In some cases these inspections are periodically carried out and will complement your condition based maintenance program. Other examples where we proved to be successful are related to 'end of warranty' inspections. To inspect rolling element bearings or planetary gearboxes we use the latest videoscopes from General Electric. These videoscopes allow us to identify problems, often impossible to see by the naked eye.

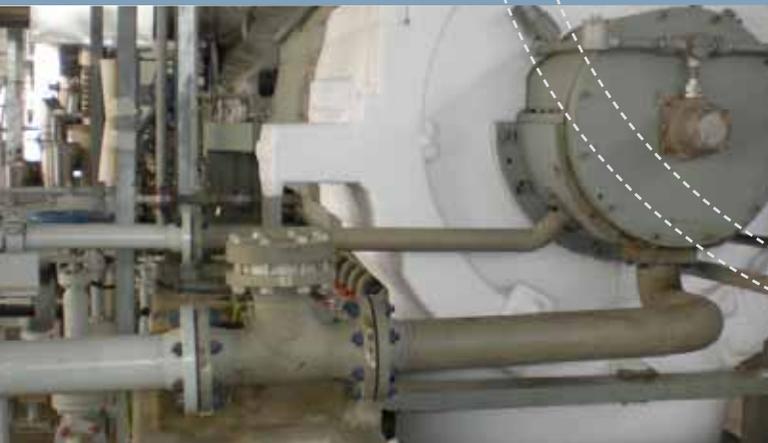
Our knowledge, experience and equipment allows us to identify potential machinery malfunctions, such as rolling element bearing defects, gear related problems, rubs, resonances, etc. Significant and valuable time can therefore be saved to resolve the problem.

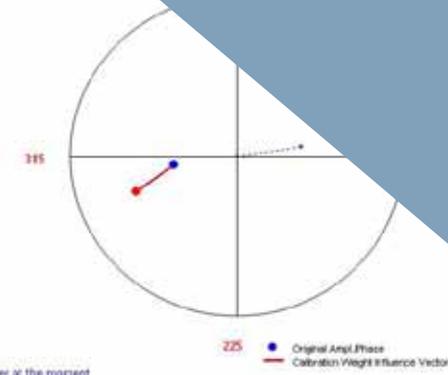
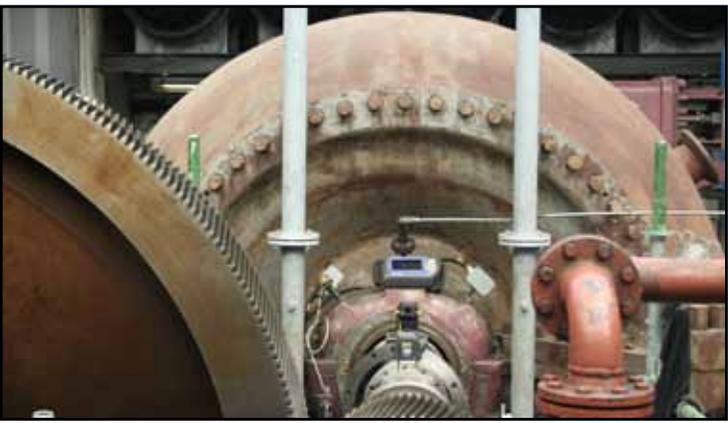
Transducer Orientation	315	0 = Top, other positions against rotational direction
Reference Run		
Amplitude	23	mm's, mils or μ m
Phase	308	Degrees Lag
Calibration Run		
Calibration weight	100	Gram
Amplitude	30	mm's, mils or μ m
Phase	298	Degrees Lag
Calculated Correction Weight		
Mass	145.0	Calculated Correction Weight
Angle	155	Look at plot for CW or CCW rotation 0° is present calibration weight position
Influence Cal. Weight 0.16		
mm's, mils or μ m / gram of weight		
Placed Correction Weight		
Concrete Position		
Mass	60	Placed Correction Weight
Angle	0	Look at plot for CW or CCW rotation
Expected Amplitude 31.9		
mm's, mils or μ m		
Phase lag: Number of degrees between the high spot of the rotor and the transducer at the moment the keyphasor strikes, measured against rotational direction.

The most common machinery problem is unbalance, which must be confirmed before attempting to balance machinery. Our specialists are trained in isolating unbalance problems and subsequently correcting them either for single plane balancing or multi-plane balancing for complex machines with one or more bearings combined with multiple measurement and correction planes.

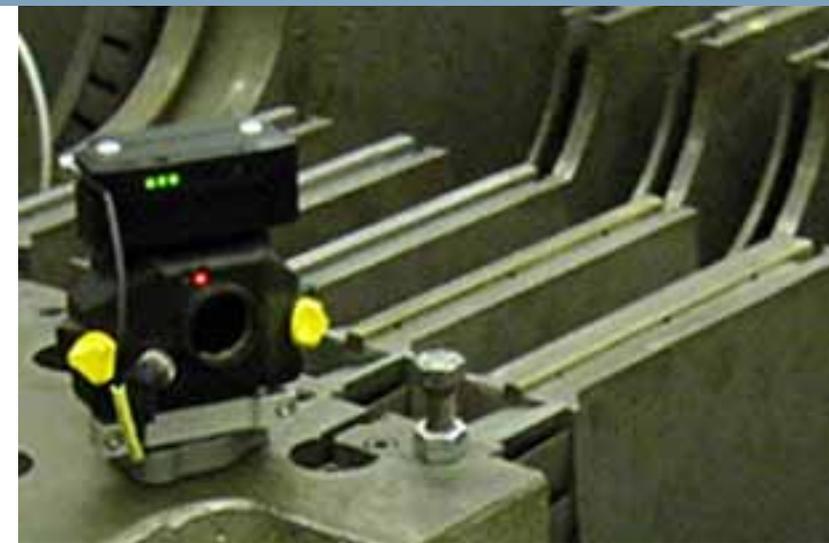
Our geometrical measurements are performed with the use of a Levalign Ultra rotating laser system from Prüftechnik. This system and the available expertise, an ideal solution for machinery foundations and weak machinery split casings, provide quick and efficient measurements of surface flatness and levelness.

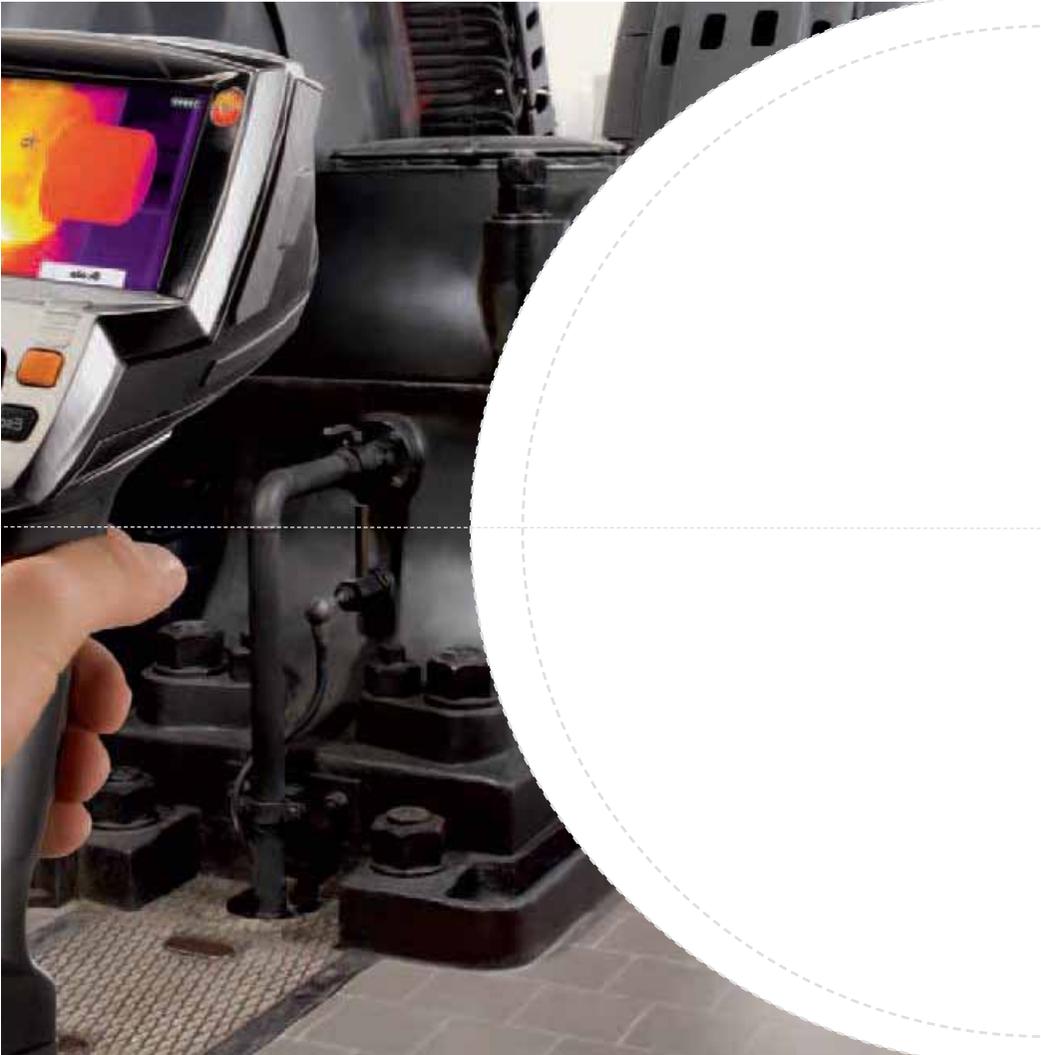
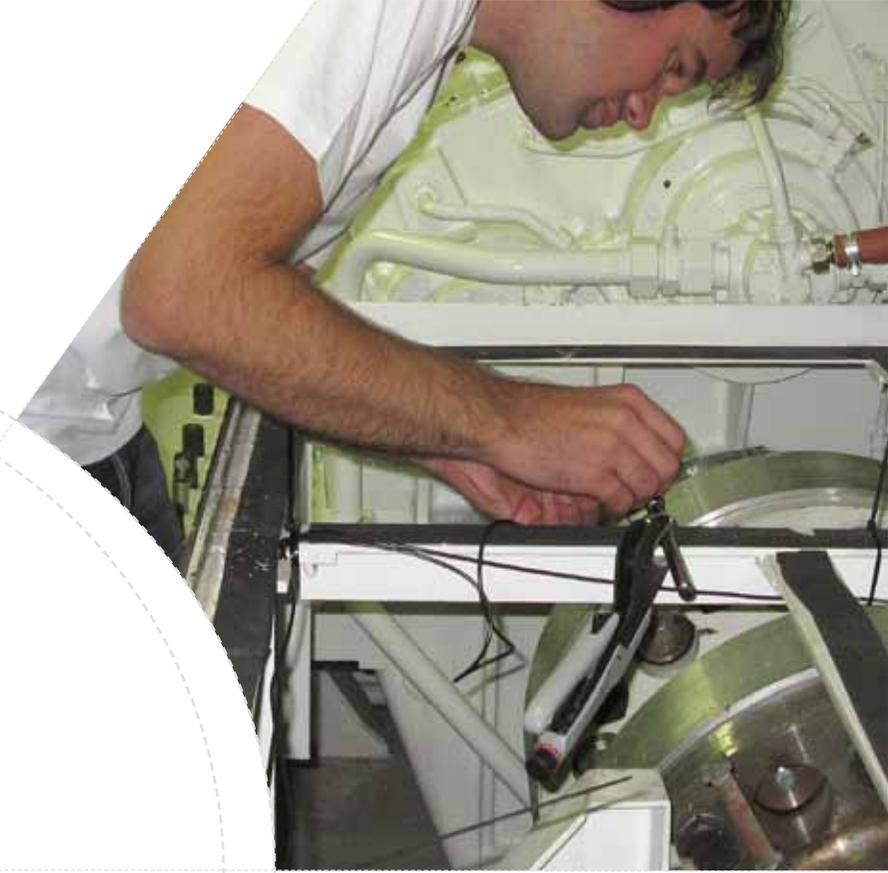
We are able to study thermal growth in machines pertaining to normal alignment or differential expansion

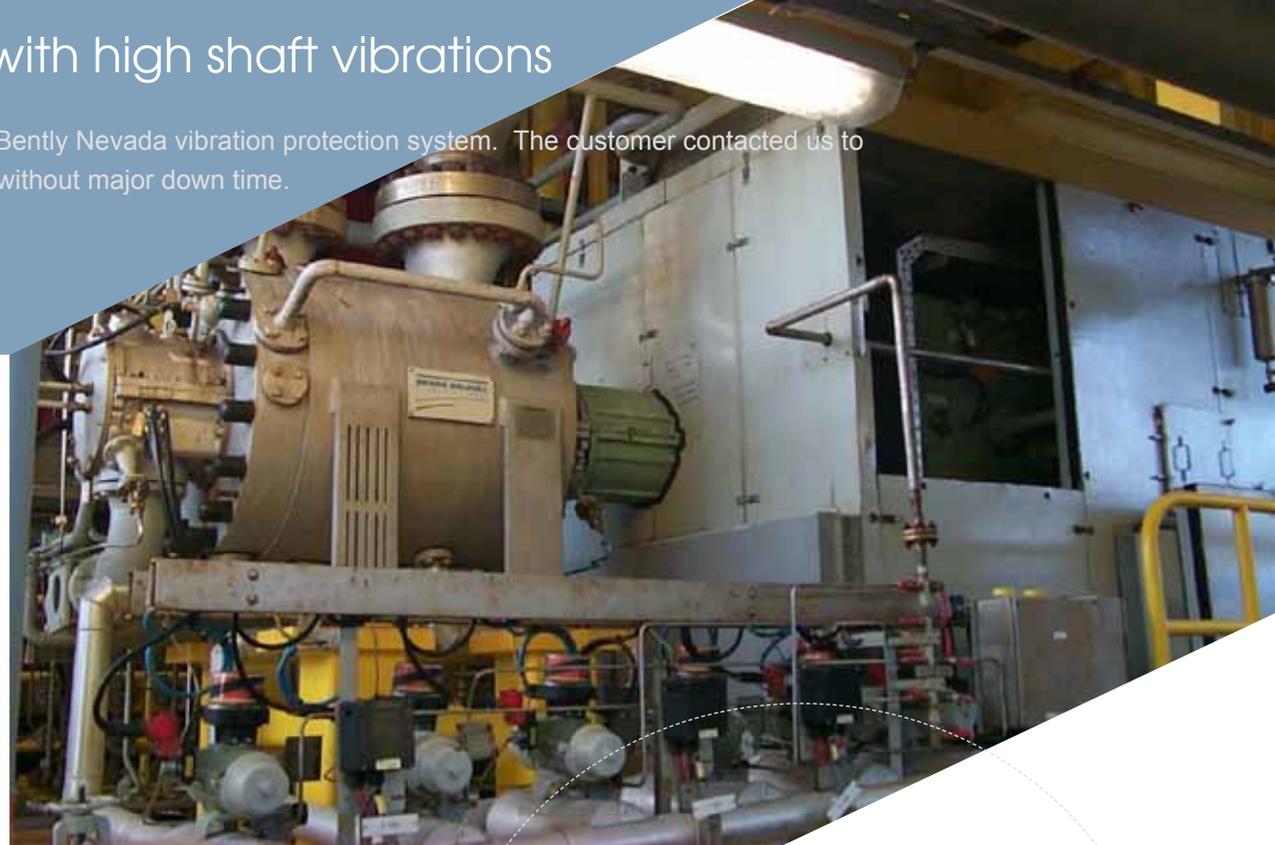
Our ADRE system was connected to the customers protection system for advanced diagnostic capabilities under different operational conditions. The recorded data had all the characteristics of unbalance. The vibration level was related to speed. The frequency was equal to the rotational frequency of the compressor and the orbit figures were circular on both ends of the rotor. It was decided not to balance the rotor in-situ due to the fact that the increase of vibration level happened suddenly, which suggests that something is stuck inside the rotor, broken of or shifted.

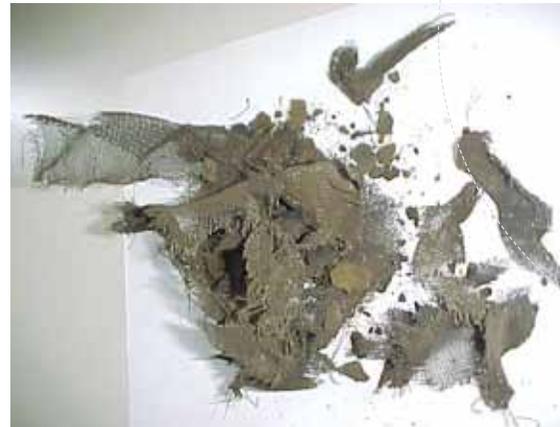
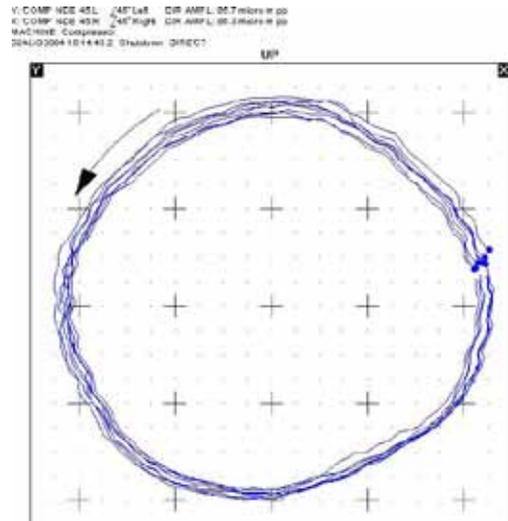
During dismantling of the compressor it became clear that a piece of strainer had entered the compressor and got stuck in one of the impellers.

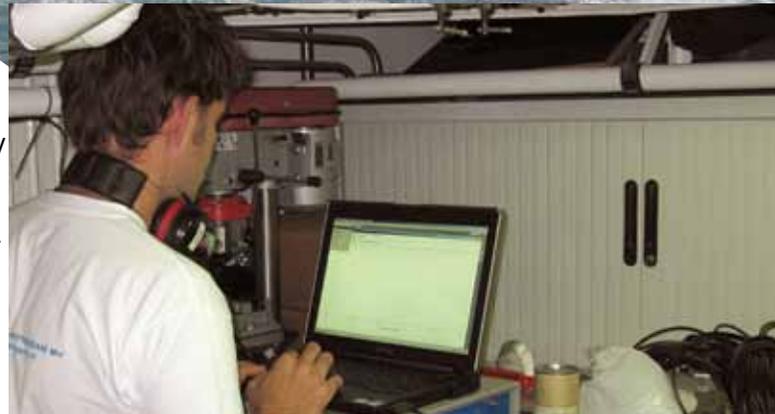
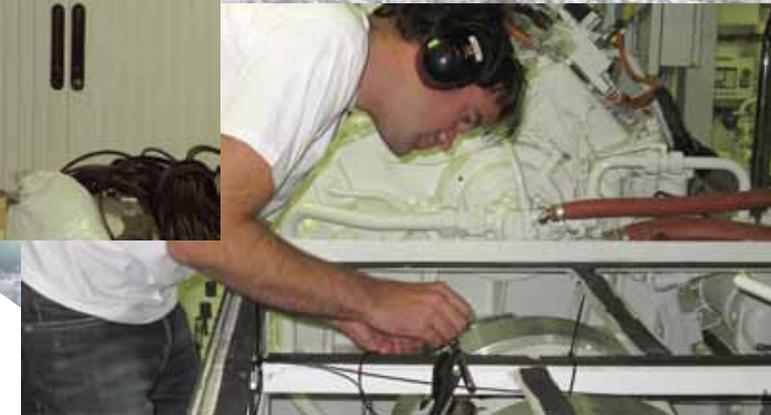
The propeller shaft manufacturer invited GBS international to investigate the behavior of the propeller shafts. During a sea trial, GBS recorded the propeller shaft displacements, using a set of two Bently Nevada 3300 series proximity probes per shaft. This way, the complete two-dimensional movement of the shaft could be monitored, at a location where vibration amplitudes were expected to be considerable. The vibration data was recorded using a Bently Nevada ADRE 208P data acquisition unit.

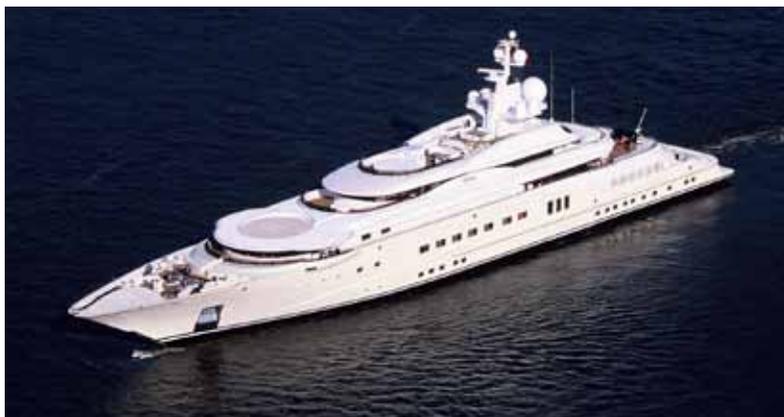
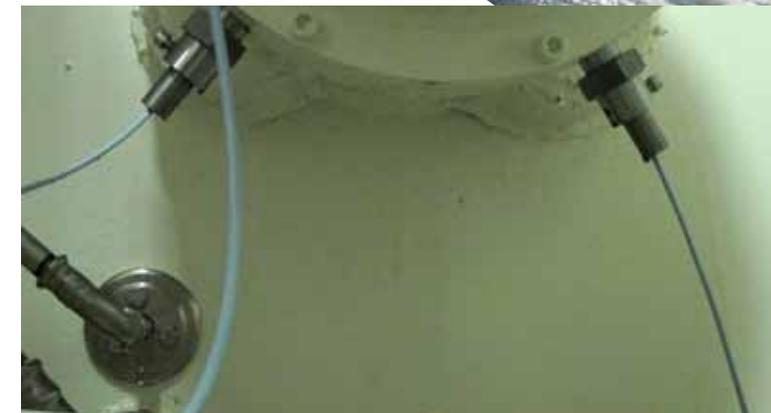
The results of the measurement were summarized and presented in a report, which was delivered to the customer within a short period. The results clearly showed the propeller shaft were not the source of the vibration, saving the customer an enormous amount of time and resources in correcting the situation.

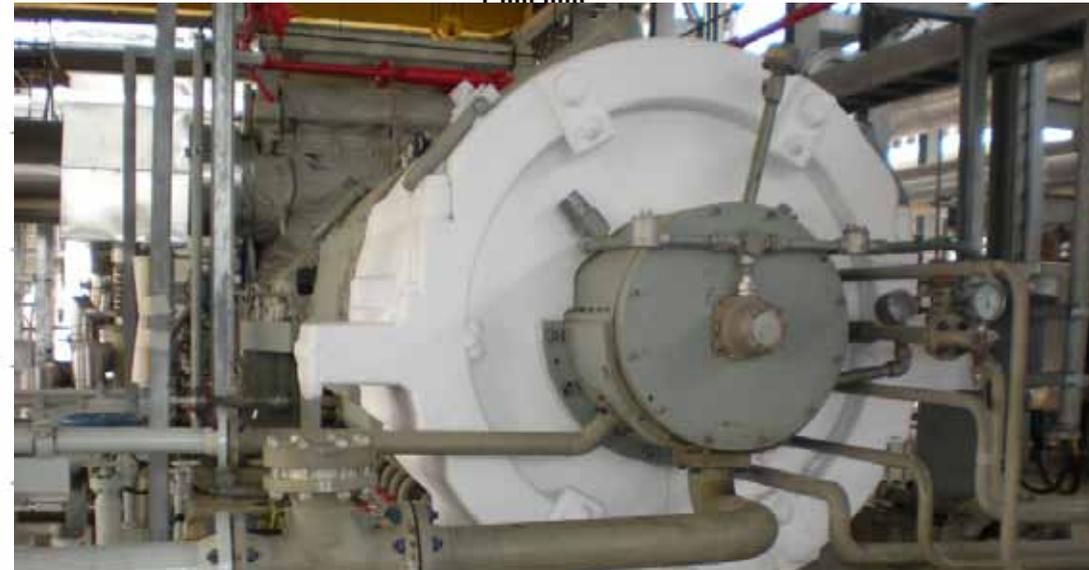
Gas turbine balancing, GE Frame 5 (MS 5001)

A customer was operating their compressor close to the vibration alarm setpoint. Our engineers were asked to analyze the problem and if possible reduce the vibration level.

Transient vibration data was recorded with our ADRE system to identify the root cause of the elevated vibration levels. In this case unbalance caused by fouling on the impellers was identified as the root cause. After repeatability of the problem was confirmed and rotor washing did not show any influence it was decided to balance the machine in situ. In situ trim balancing is a very cost effective way to reduce elevated vibration level without taking the machine apart.

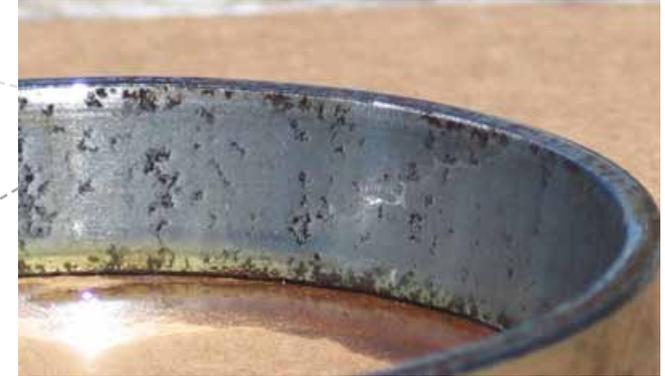
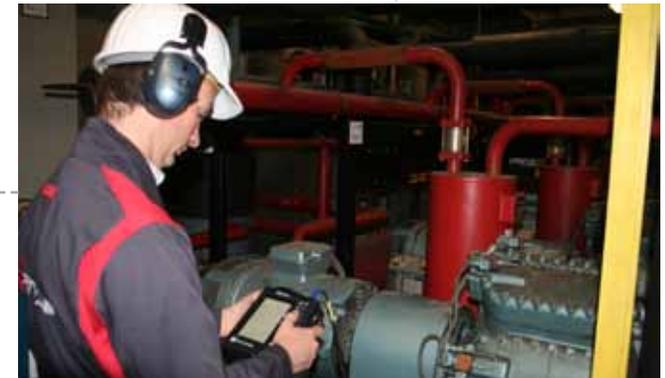
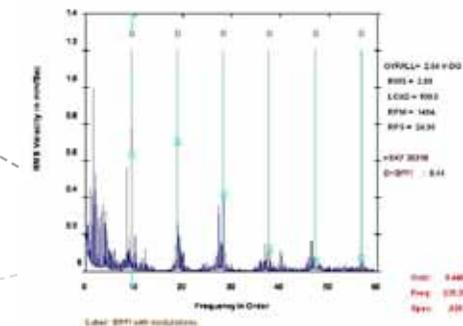
A rolling element bearing inner ring defect was identified in the plot right.

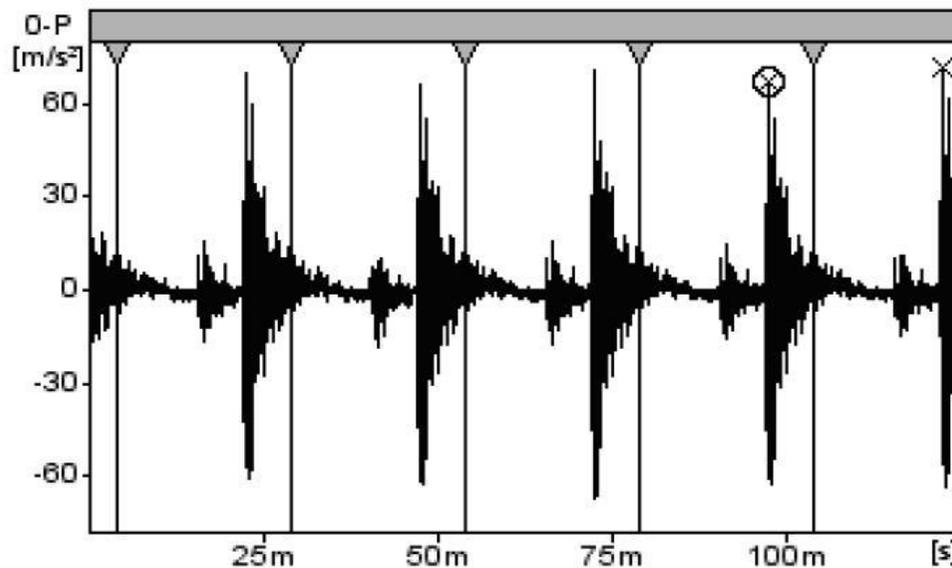
To identify the specific gear and even the specific tooth causing the impact we used our portable data acquisition system in combination with an acceleration sensor and a keyphasor. The plot below the result when collecting the data. The vertical line represents the passing keyphasor (trigger) mark, while the impact is shown by a spike in the signal. Calculation of the exact position of the impact is now possible.

Sometimes hand grinding is enough to remove the burrs caused by an indentation. In other occasions it is necessary to re-grind the gears by a specific gear grinding machine.

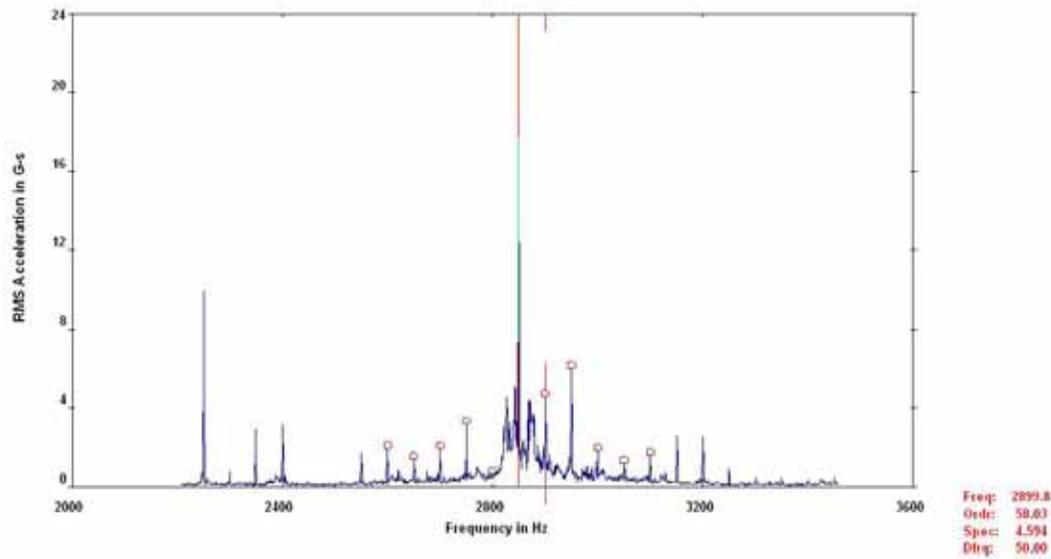
By recording the gearbox casing vibrations we were able to identify the particular gear that was causing the increased vibration level. In this case the damage was too severe and the gear had to be re-placed. In other cases however with minor damage it might be sufficient to replace the bearings when excessive bearing clearance is the root cause.

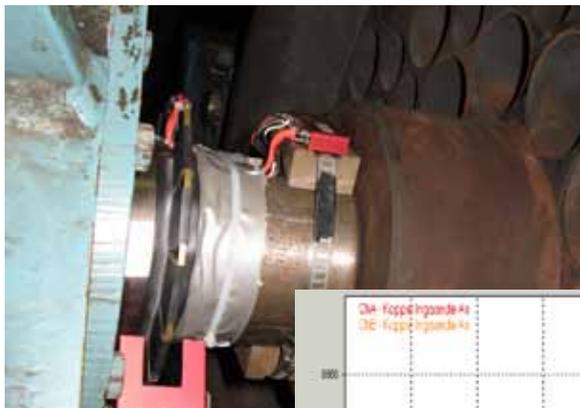
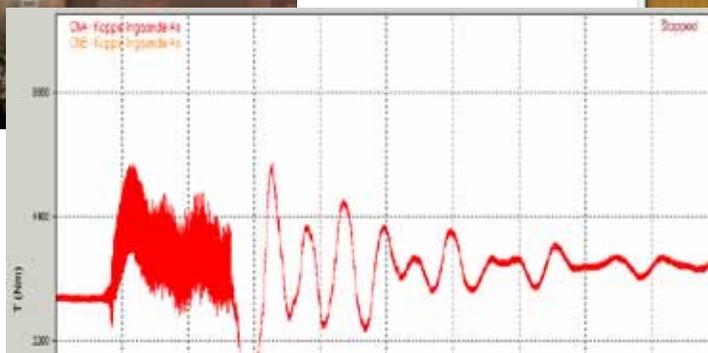
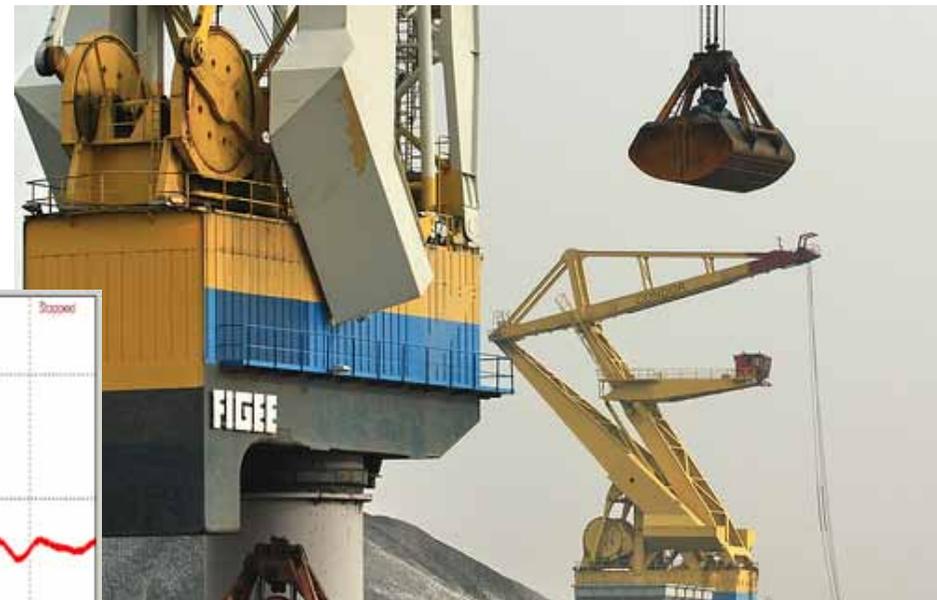
We installed a torque measurement system on the gearbox input shaft between the gearbox and the brake drum. The torque signal was monitored and compared to the motor current indication. During a full day of measurements under normal production conditions, we observed two major shortcomings in the system:

- The motor current indication setup was incorrect, the indicated motor torque was too low.
- The gearbox was systematically being overloaded, especially during rough operation of the crane in a nearly empty ship.

Based on the results, the motor current indication could be calibrated. This way, overloading of system by rough handling could be noticed by the crane driver. Also, the design of the input shaft pinion was modified, so it could withstand greater loads.

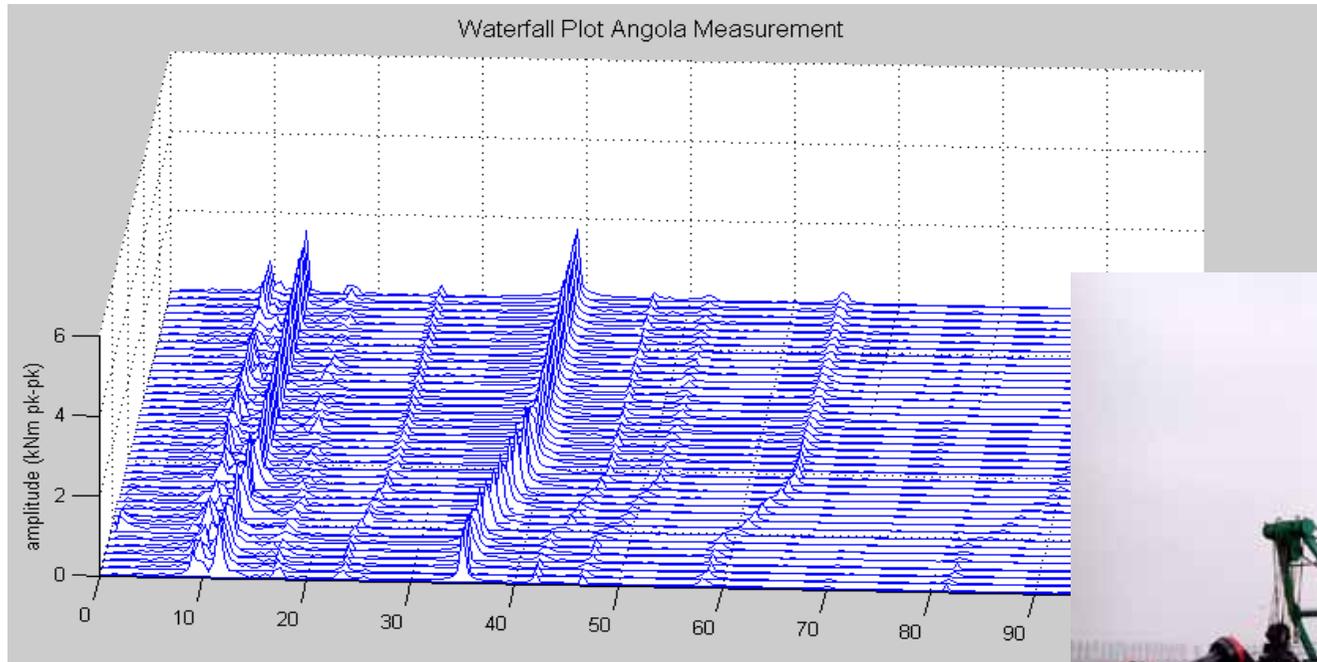
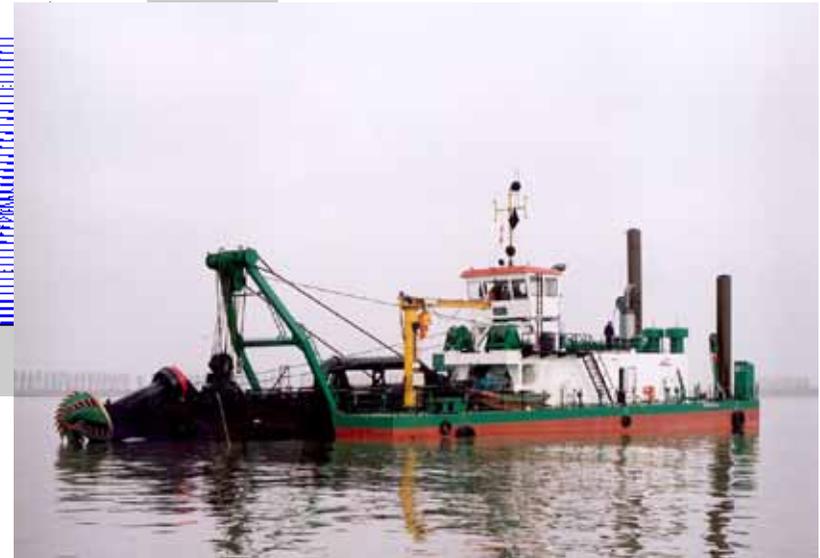
By installing a torque measurement system on the carbon fiber drive shaft, connecting the diesel engine to a gearbox, we could monitor the torsional vibration during many different operational conditions. On the output side of the gearbox, a second system was installed. Using the two signals, we were able to map the dynamic behavior of the complete drive train.

A torsional resonance over the flexible coupling was identified. The customer sent the report to the coupling manufacturer, who could redesign the coupling elements to avoid the resonance.

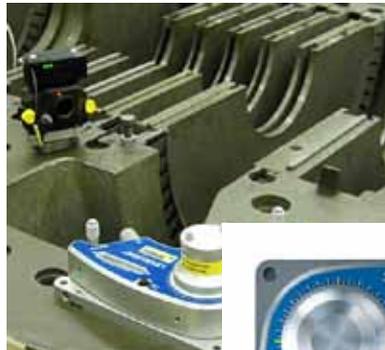
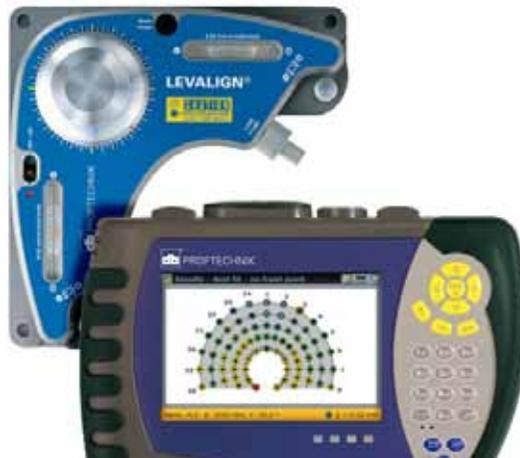
Rotalign Ultra Laser Alignment system

Our ROTALIGN Ultra is the number 1 tool in laser alignment equipment. This high-performance system incorporates exclusive measurement modes that provide very accurate results for any application, and enables simultaneous live monitoring of both vertical and horizontal machine corrections. Specialist analysis tools like the soft foot diagnostic tool have also been integrated for an accurate assessment of the machine condition.
